GLADE COMMUNITY
WATERSHED ANALYSIS

GLADE CREEK MUNICIPAL WATERSHED

WATER MANAGEMENT OF NORTH IDAHO
J. ALLEN ISAACSON
HYDROLOGIST

MAY 14, 1994

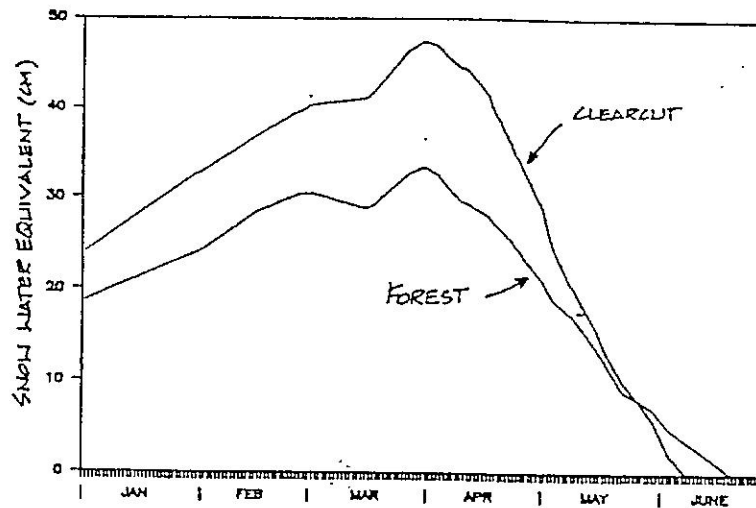
The paper by Toes and Gluns "TRANSLATING SNOW HYDROLOGY RESEARCH RESULTS INTO GUIDELINES FOR FOREST MANAGERS: GAPS BETWEEN THEORY AND PRACTICE", shows that there is increased snow accumulation and also quicker melt and removal of the snowpack on a North slope site near Rossland B.C.. This is similar to what we found in monitoring in Northern Idaho, we have much more data and flow records now. That would show answers to some of their questions. The proposed activity in Glade is on South slopes which react even quicker to increased snow and quick spring melt due to the orientation to the sun. Not only the facing south or southwest but the angle of the slope to get the spring direct energy from the sun. The snow can be removed by up to 3-4 weeks quicker. This would result in a higher spring peak in Glade and lower summer flows. In some years this is already a problem, and as the pine grows back there will be less water at the intake. but one peak flow early in the spring will not help, it will hurt by removing snow that would be storage for later in the spring. A research paper from Alaska by Myron this spring 1994 shows the lose of late summer flows from cutting in a similar watershed. Below is a graph of the Rossland data from Toes and Gluns

Figure 1. Average snow accumulation and ablation (1983-1987) for a north facing site at 1375 m elevation near Rossland, B.C.
